**BUILDING & TERMITE INSPECTIONS**

Report: 0003545

## **Pre Purchase Building & Timber Pest Inspection Report**

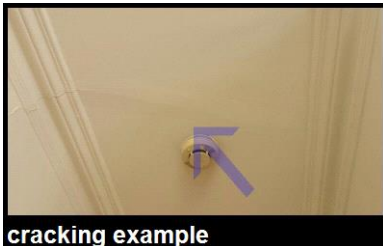
\* Settlement cracks and undulation was noted to the ceilings within most rooms. This can be expected to a dwelling of this age, but periodic maintenance will be required by a suitably qualified plasterer to prevent further deterioration.

cracking example

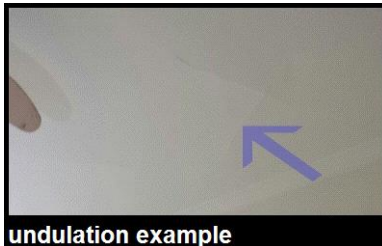
undulation example

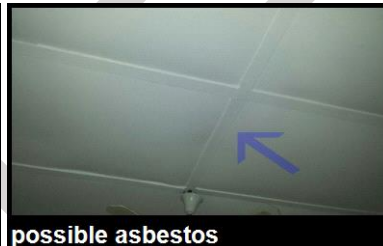
\* Its highly possible asbestos cement sheeting may be present to the front master bedroom ceilings. Asbestos material should not be disturbed or damaged and should be kept well maintained and sealed to prevent exposure. Due to the nature of asbestos and the hazards to health it can pose, it should only be removed or modified only by a licensed asbestos removal contractor.

possible asbestos

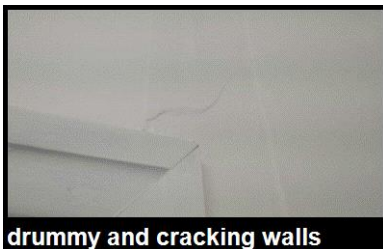
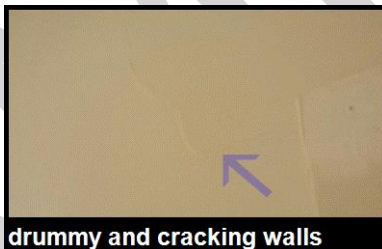
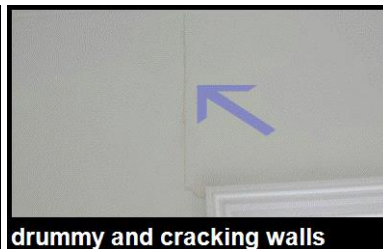
\* There are areas of drummy render and plaster though out the dwelling. This is where the plaster and or render does not adhere properly to the brickwork or substrate. Although only cosmetic, rectification can be quite costly. Periodic maintenance will be required, and badly affected areas will need to be re-rendered by a suitably qualified solid plasterer.

drummy and cracking walls

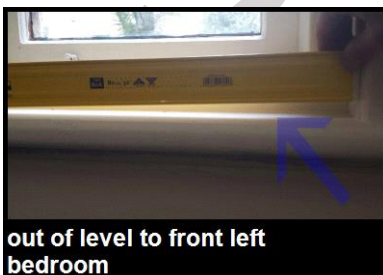
\* The front left bedroom window is out of level. This aligns with the uneven level floors, and structural movement noted to the floors to this area. (Please see FLOORS - General Conditions within this report for further details)

out of level to front left bedroom

\* The rest of the windows require minor adjustment to ensure smooth operation. A licensed carpenter should be called to make a further evaluation and repairs or rectification as needed.

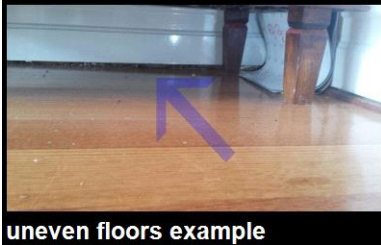
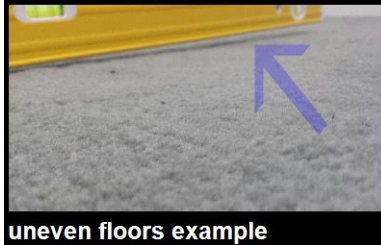
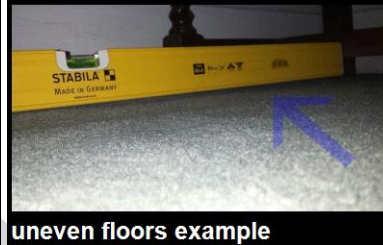
\* Floors levels have subsided and are uneven to Bedroom 1. This appears to be a result of foundation movement and timber stump decay noted (Please see SUBFLOOR - Wood Decay Damage within this report for further details). The foundations may need to be secured, and the decayed timber stumps replaced to rectify this issue. A licensed builder should be called to make a further evaluation and repairs or rectification as needed.

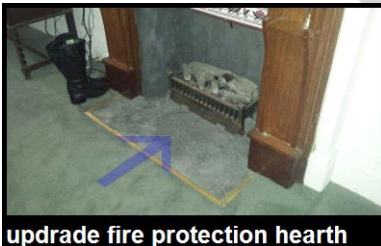
\* A heating appliance is present and located adjacent to combustible materials. Recommend the heat shield and hearth be upgraded to protect from fire. The flue should also be checked for safety particular within the roof void. The current standards should also be checked for more detail and any rectification made by a suitably qualified professional.

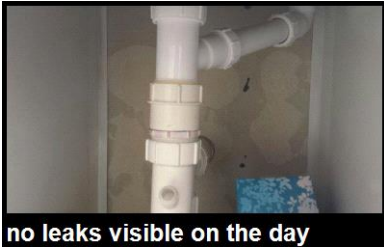
\* The tub and taps appear serviceable.

no leaks visible on the day

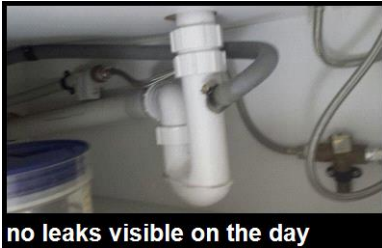
\* The sink and taps appear to be in a serviceable condition.

no leaks visible on the day

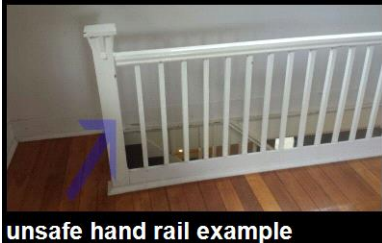
\* The internal stairs are constructed primarily from timber. Movement is evident to the balustrade, and this presents as a safety issues. Rectification is required. A licensed carpenter should be called to conduct repairs or rectification as needed.

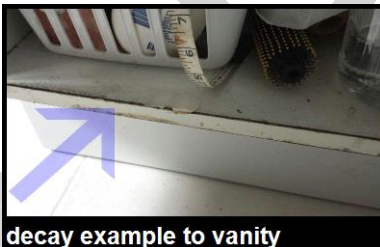
- \* The basin & taps appear serviceable and function as intended.
- \* Minor decay from past leakage was noted to the vanity unit. No leaks were visible on the day, but this should be monitored ongoing.

decay example to vanity

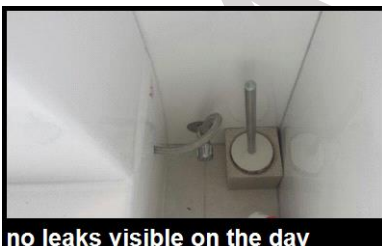
- \* The toilet appears to be in working order.

no leaks visible on the day

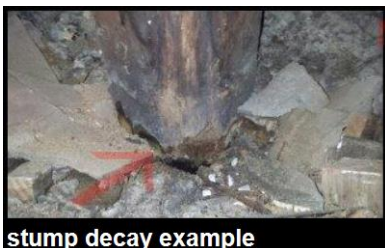
\* Internal timber stumps showed signs of rot at ground level under the bedroom 1 and bedroom 2 regions. This appears to be the cause of the uneven floors internally. The extent of the rot could be more significant below ground level. Replacement of the timber stumps to these areas is required. A licensed builder should be called to make a further evaluation and repairs or rectification as needed.

stump decay example

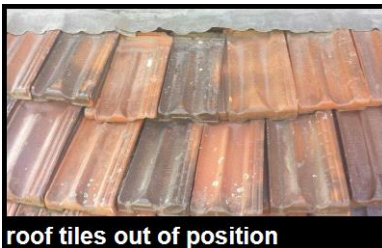
- \* The overall condition of the roof coverings is fair.
- \* Some tiles mainly to the front elevation are out of place, and need re setting to assure no water can penetrate into the dwelling. A licensed roof tiler should be called to make minor repairs or rectification as needed.

roof tiles out of position

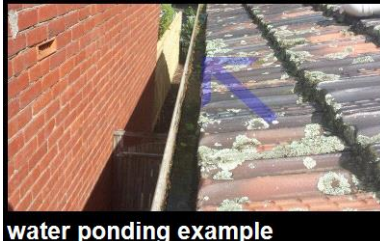
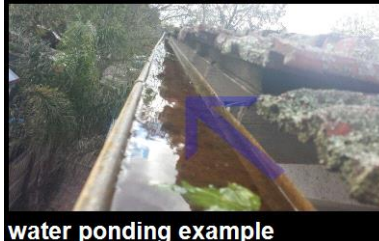
- \* All downpipes to the dwelling are not connected to a stormwater dispersal system. This should be rectified to prevent decay to surrounding components. This also effects the timber pest management of the property. A licensed roof plumber should be called to connect all downpipes to the storm water system.
- \* Water is ponding in the gutters and they require realigning. They are also blocked in areas with leaves. This not only effects the timber pest management of the property, but also substantially reduces the life of the gutter material. Rectification is required by a licensed roof plumber.

water ponding example

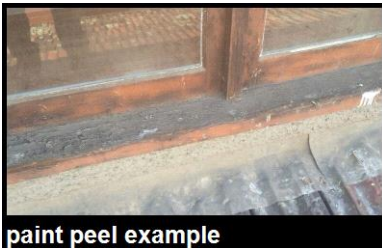
\* Paint is peeling off the window frames and maintenance is required to prolong the life of the window materials. A painter should be called to make a further evaluation and repairs or rectification as needed.

paint peel example

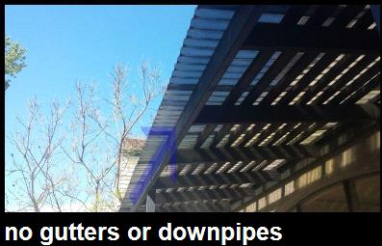
\* No gutters or downpipes are installed, and this effects the timber pest management of the property. Gutters and downpipes should be installed and connected to the stormwater system by a licensed roof plumber.

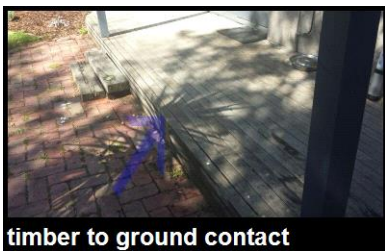
\* Decking floor framing is touching or nearly touching the ground. This may allow undetected timber pest entry. Provision should be made so no timber to ground contact exists.

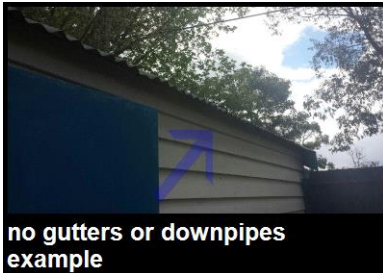
- \* No gutters or downpipes are installed and this effects the timber pest management of the property. Gutters and downpipes should be installed and connected to the stormwater system by a licensed roof plumber.

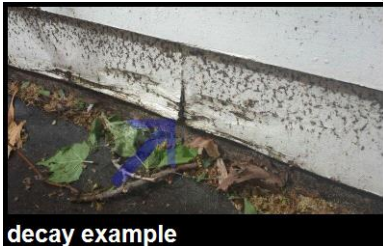
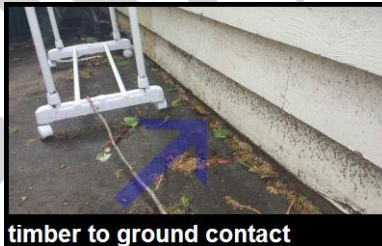
- \* Wet rot decay is present to external base weather boards. Recommend decayed timbers be repaired or replaced by a licensed carpenter.
- \* External timbers are in contact with or very close to soil areas. This is conducive to timber pest attack or timber deterioration and we recommend modifications be made so that timber to soil contact does not occur.

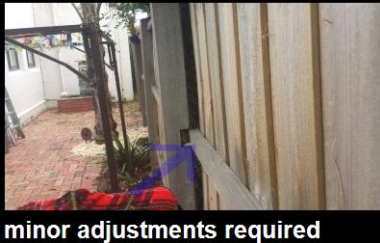
\* The fences are mainly constructed from timber. The fences are generally in fair condition, but some minor repairs or maintenance is required by a licensed carpenter.

minor adjustments required

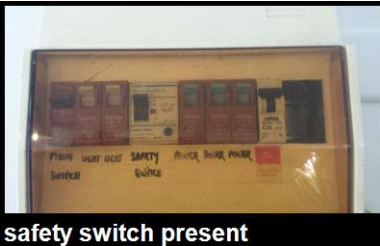
\* Safety switch is fitted however, the operation or adequacy was not tested and is not commented on. Recommend to contact a licensed electrician to assure the electrical safety switch is functioning as intended.

safety switch present

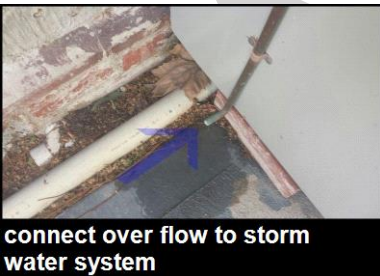
\* The hot water over flow pipe doesn't appear connected to the storm water system. This effects the timber pest management of the property. Recommend the overflow be connected to the stormwater system by a licensed plumber.

connect over flow to storm water system

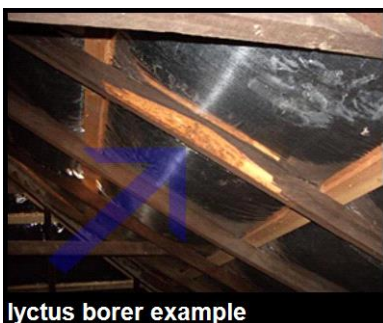
Visible timber damage appears minor to moderate. Refer to the definitions section of this report - Section 1.6 - Timber Damage.

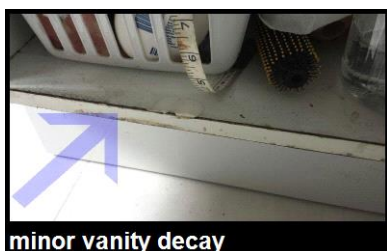
Visible timber damage appears minor. Refer to the definitions section of this report - Section 1.6 - Timber Damage.

minor vanity decay

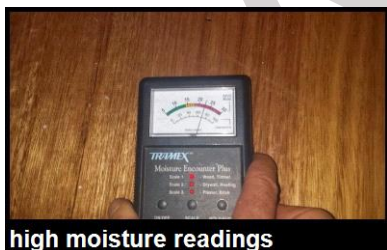
Bedroom one and bedroom two.

high moisture readings

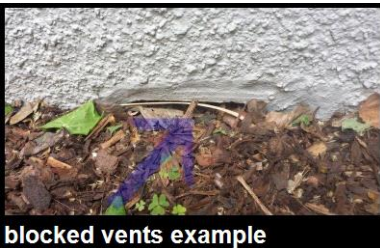
We also noted that some vents appear to be partly concealed or covered. Vents should always remain uncovered otherwise ventilation will be compromised. Partly covered vents can also facilitate concealed termite entry.

**blocked vents example**

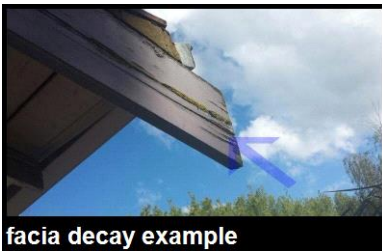
Visible timber damage appears minor. Refer to the definitions section of this report - Section 1.6 - Timber Damage.

facia decay example

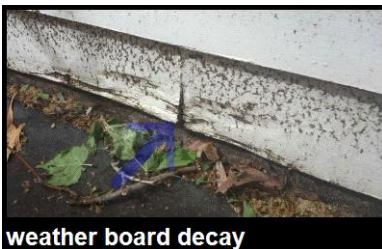
Visible timber damage appears moderate and some weatherboard replacement is required. Refer to the definitions section of this report - Section 1.6 - Timber Damage.

weather board decay

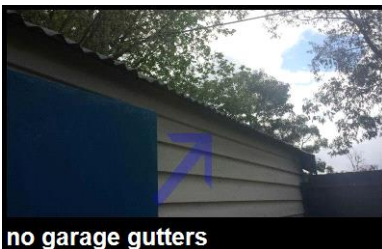
No gutters or downpipes are installed and this effects the timber pest management of the property. Gutters and downpipes should be installed and connected to the stormwater system.

no garage gutters
